## PROGRESS REPORT

# ARCHAEOLOGICAL SITE OF BAALBEK

## Capacity building of human resources for digital documentation of world heritage sites affected by 2006 war in Lebanon

### **REPORT**

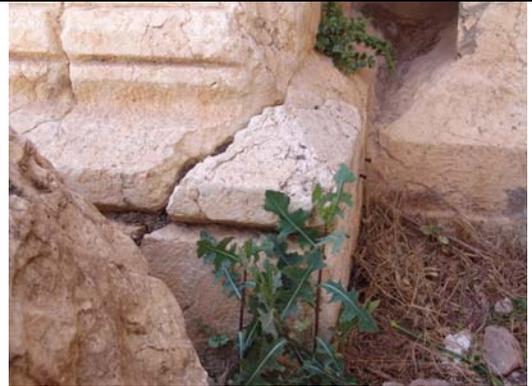
##### a) Fracture

*Crack that crosses completely the stone bloc*

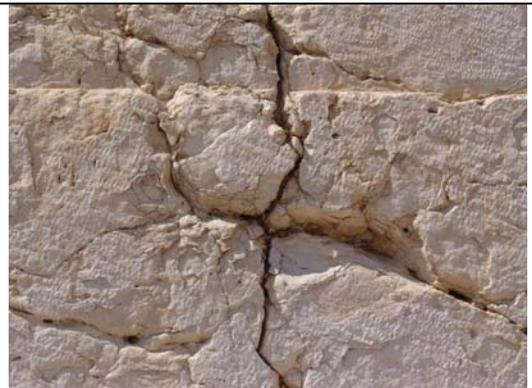
##### b) Star crack

*Crack having the form of a star. Rusting iron or mechanical impact are possible causes of this type of damage*

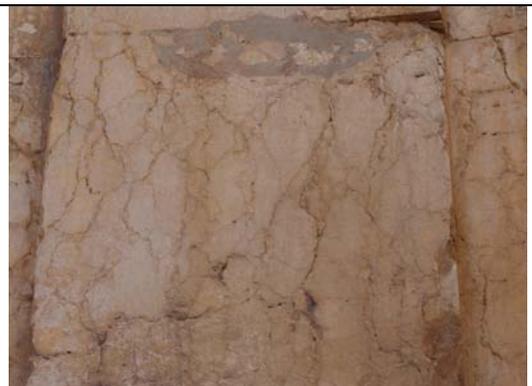
##### e) Splitting

*Fracturing of a stone along planes of weakness such as microcracks or clay/silt layers, in case where the structural elements are orientated vertically*

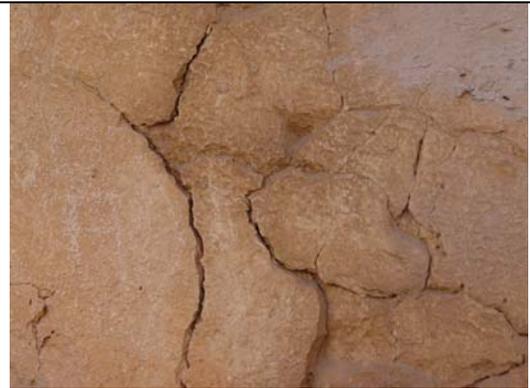
f) Crack  
*Individual fissure, clearly visible by the naked eye*

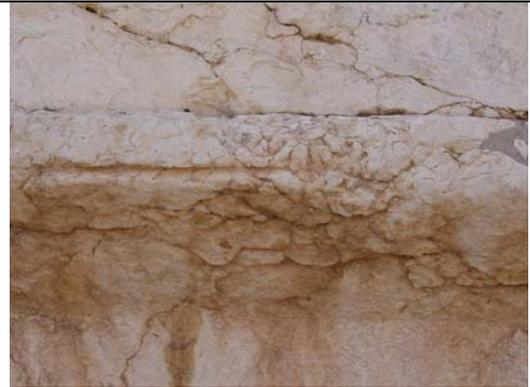
**B.4 Disintegration** a) Crumbling  
*Detachment of single grains or aggregates of grains* *Detachment of aggregates of grains from the substrate. These aggregates are generally limited in size (less than 2 cm)*

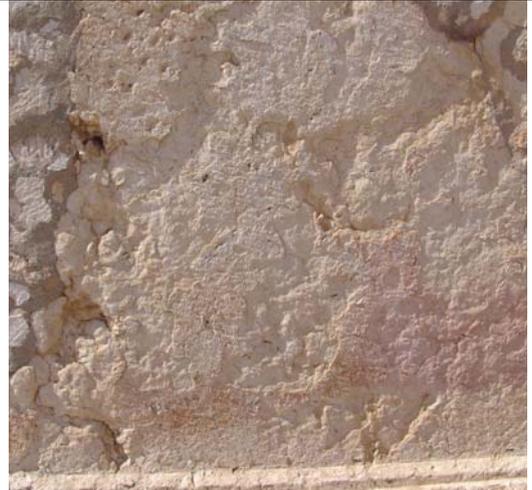
### B.6 Peeling

*Shedding, coming off, or partial detachment of a superficial layer (submillimetric to millimetric)*

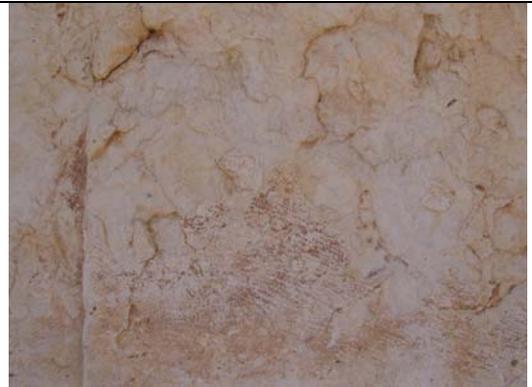
### B.7 Scaling

*Detachment of scale or stack of scales, not following any stone structure, detaching like fish scales or parallel to the stone surface. The thickness of a scale is generally of millimetric to centimetric scale*

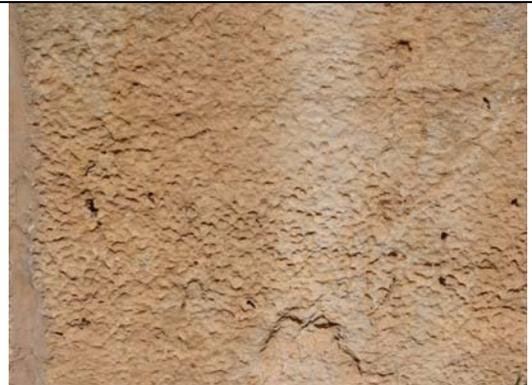
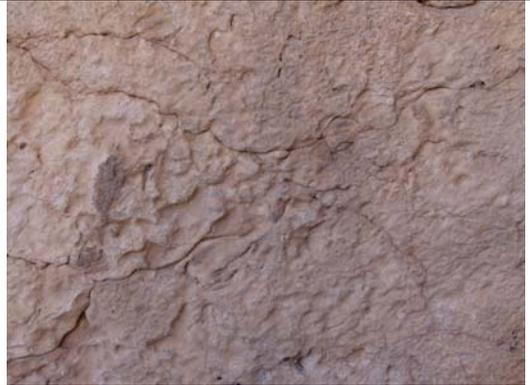
### C.1 Alveolization

*Formation on surface of cavities (alveoles) which may be interconnected and may have variable shapes and sizes (generally centimetric, sometimes metric)*

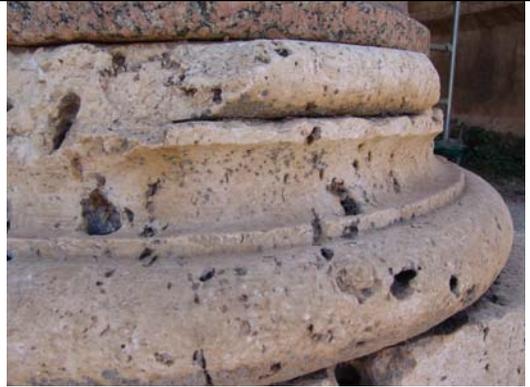
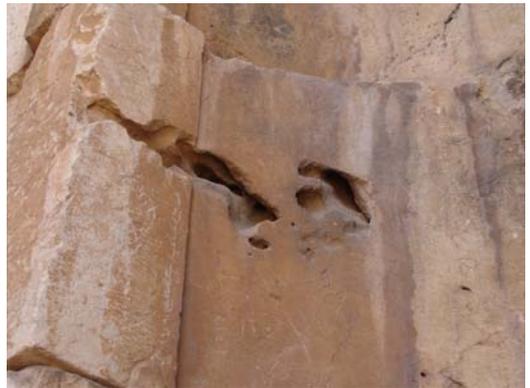
a) Differential erosion

*Occurs when erosion does not proceed at the same rate from one area of the stone to the other. As a result, the stone deteriorates irregularly. This feature is found on heterogeneous stones containing harder and/or less porous zones. Differential erosion may result in loss of components or loss of matrix of the stone*

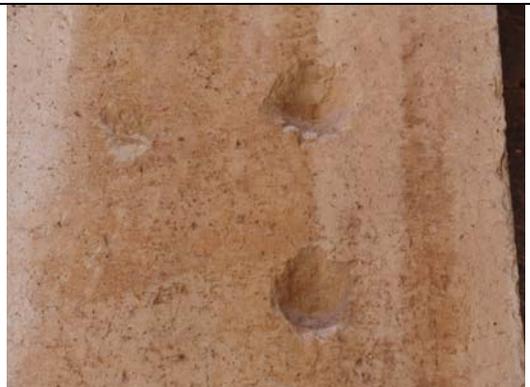
a) Impact damage

*Mechanical damage due to the impact of a projectile (bullet, shrapnel) or of a hard tool*

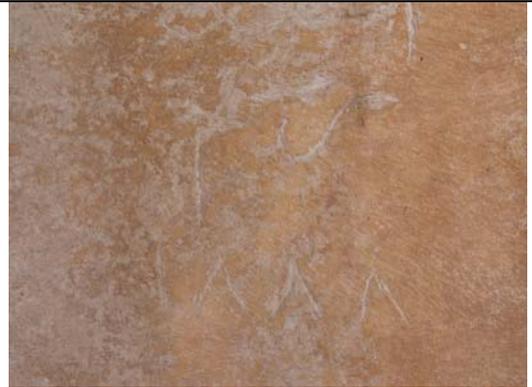
c) Scratch

*Manually induced superficial and line-like loss of material due to the action of some pointed object. It can be accidental or intentional*

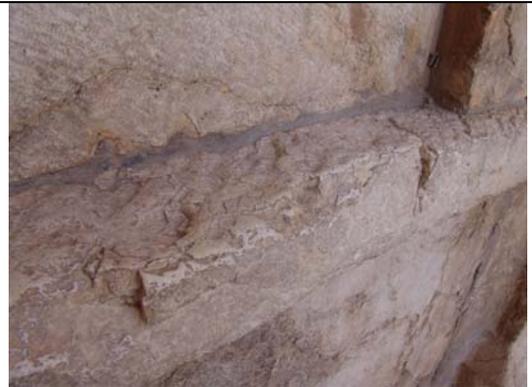
d) Abrasion

*Erosion due to wearing down or rubbing away by means of friction, or to the impact of particles*

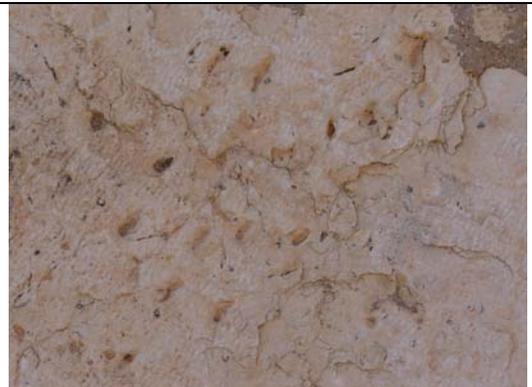
e) Keying

*Impact damage resulting from hitting a surface with a pointed tool, in order to get an irregular surface which will assist the adhesion of an added material, a mortar for instance*

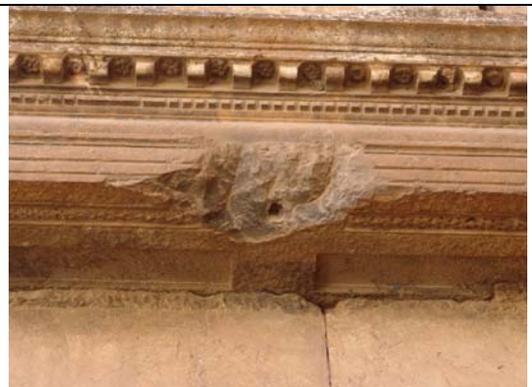
**C.5 Missing part  
(gap)**

*Empty space, obviously located in the place of some formerly existing stone part*

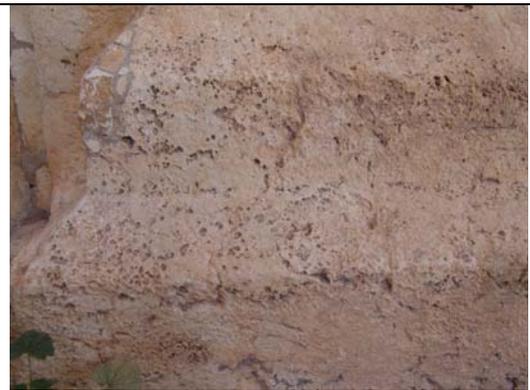
**C.7 Pitting**

*Point-like millimetric or submillimetric shallow cavities. The pits generally have a cylindrical or conical shape and are not interconnected*

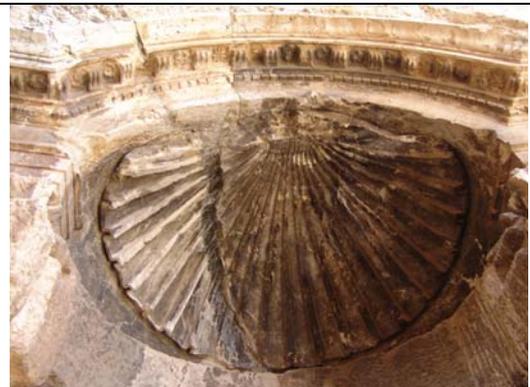
a) Black crust

*Crust developed generally on areas protected against direct rainfall or water runoff. Black crusts usually adhere firmly to the substrate. They are composed mainly of particles from the atmosphere, trapped into gypsum ( $\text{CaSO}_4 \cdot 2\text{H}_2\text{O}$ ) matrix.*

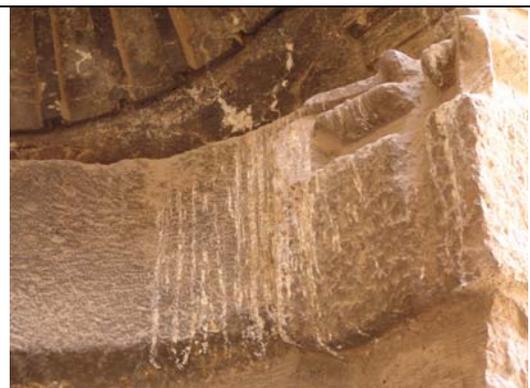
**D.2 Deposit**

*Accumulation of exogenic material of variable thickness (splashes of paint or mortar, sea salt aerosols, atmospheric particles such as soot or dust, bird and bat droppings, etc...)*

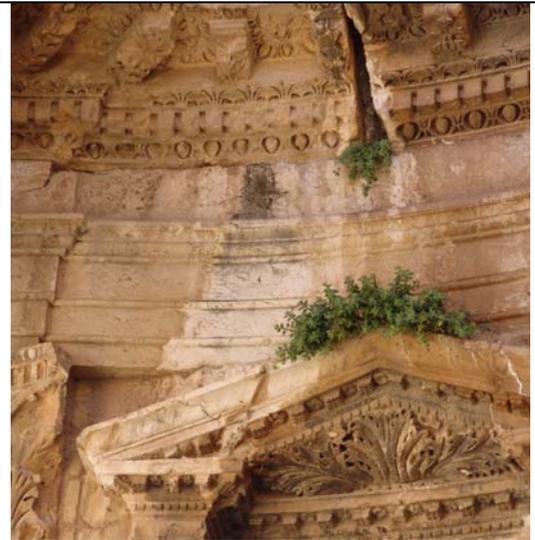
**b) Bleaching**

*Gain in value due to chemical weathering of minerals (reduction of iron and manganese compounds) or extraction of colouring matter (leaching, washing out)*

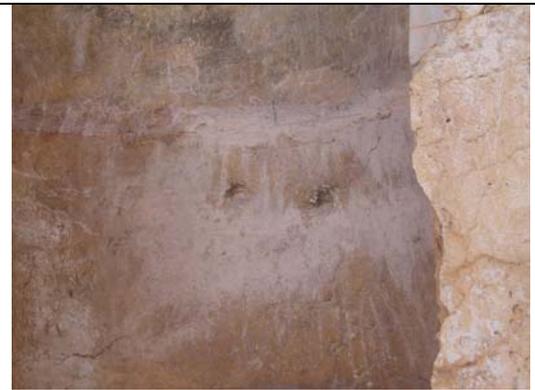
**d) Staining**

*Kind of discoloration of limited extend and generally of unattractive appearance*

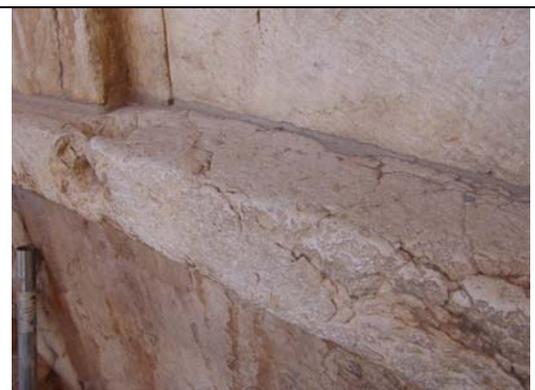
**D.7 Glossy aspect**

*Aspect of a surface that reflects the light totally or partially. The surface has a mirror-like appearance*

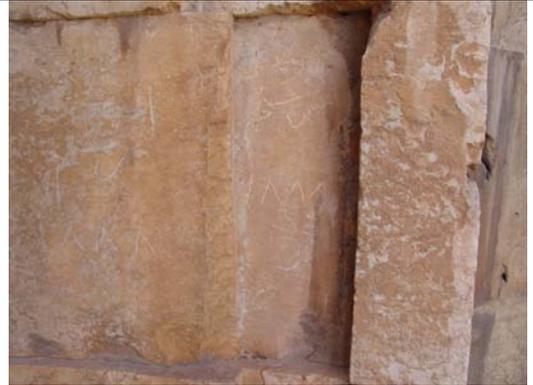
**D.8 Graffiti**

*Engraving, scratching, cutting or application of paint, ink or similar matter on the stone surface*

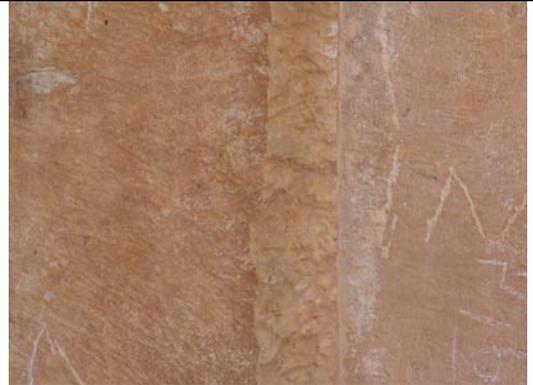
**D.9 Patina**

*Chromatic modification of the material, generally resulting from natural or artificial ageing and not involving in the most cases visible surface deterioration*

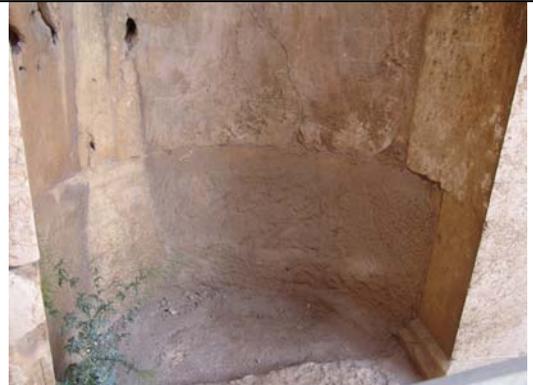
**D.10 Soiling**

*Deposit of a very thin layer of exogenous particles (soot) giving a dirty appearance to the stone surface*

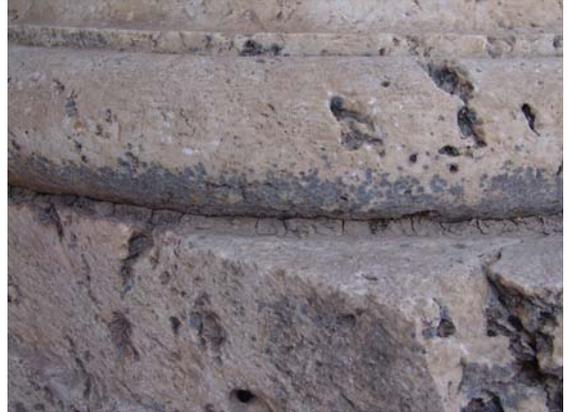
### E.2 Lichen

*Vegetal organism forming rounded millimetric to centimetric crusty or bushy patches, growing generally on outside parts of a structure. Lichen are most commonly grey, yellow, orange, green or black*

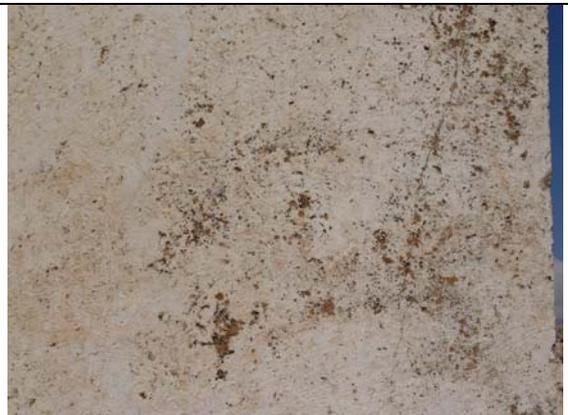
### E.3 Moss

*Vegetal organism forming small, soft and green cushions. Mosses look like dense micro-leaves packed together. Normally grow in any place permanently or often wet and usually shady*

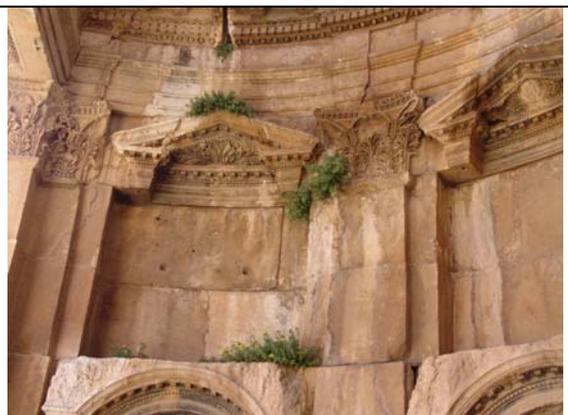
### E.5 Plant

*Vegetal living being, when complete, root, stem, and leaves, though consisting sometimes only of a single leafy expansion (tree, herb, ...)*
