**COMPLETION REPORT FOR PROJECT: A5-04
OSRO/IRQ/404/UDG**

OSRO/IRQ/404/UDG

Assessment, emergency, maintenance and rehabilitation of community irrigation schemes and restoration of water supply in rural areas.

Report Number: Final

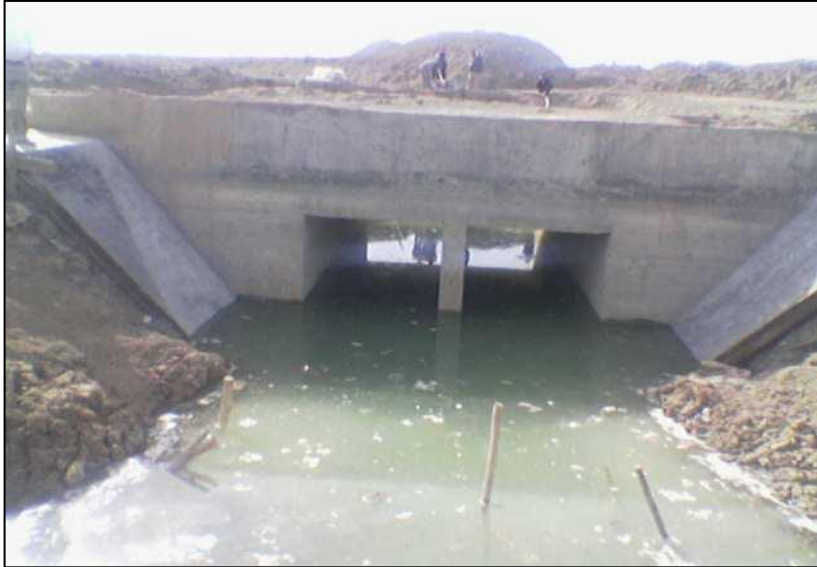
Culvert

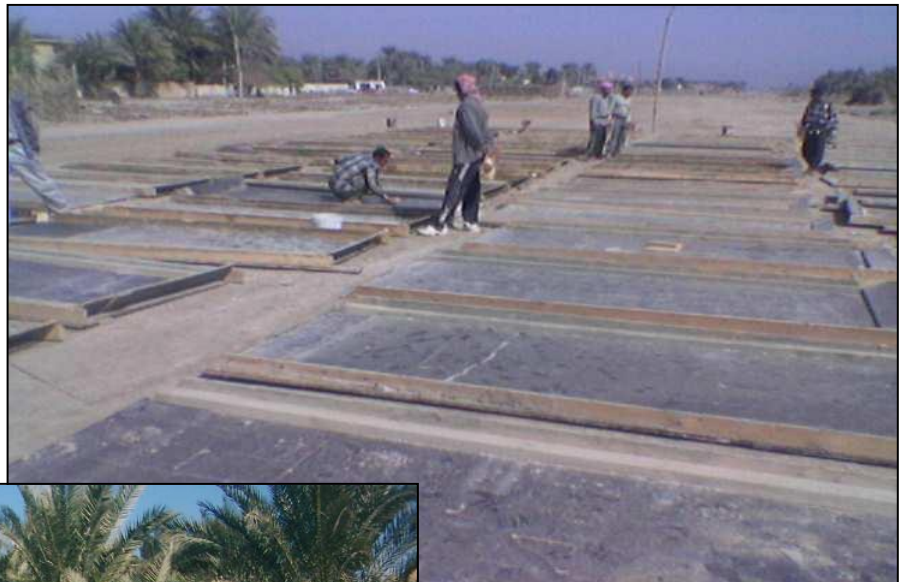
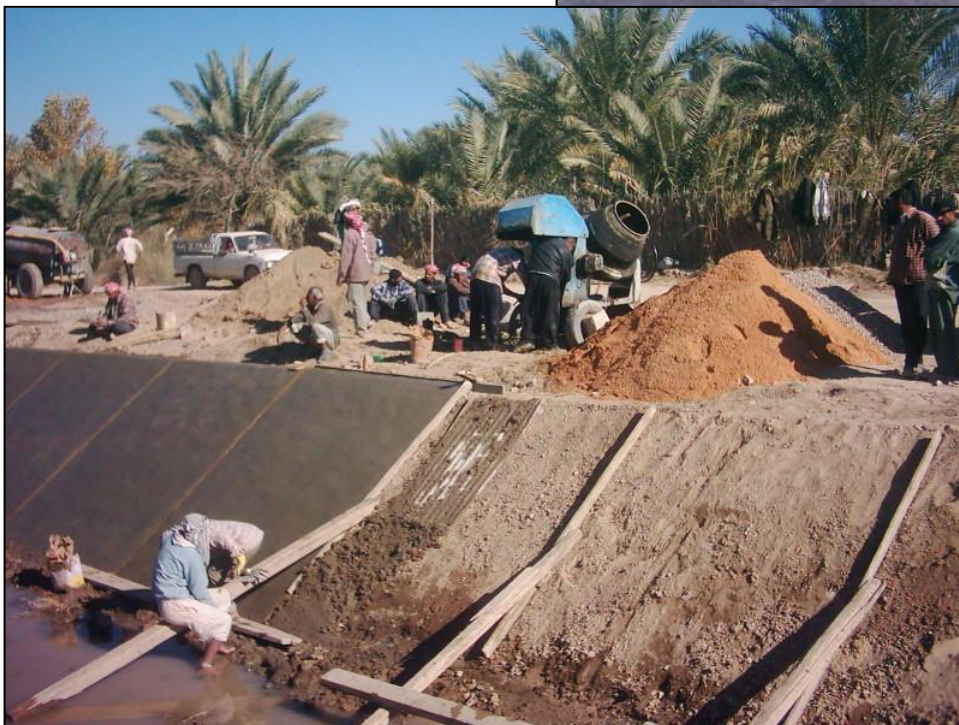
Pre-cast concrete lining for canals

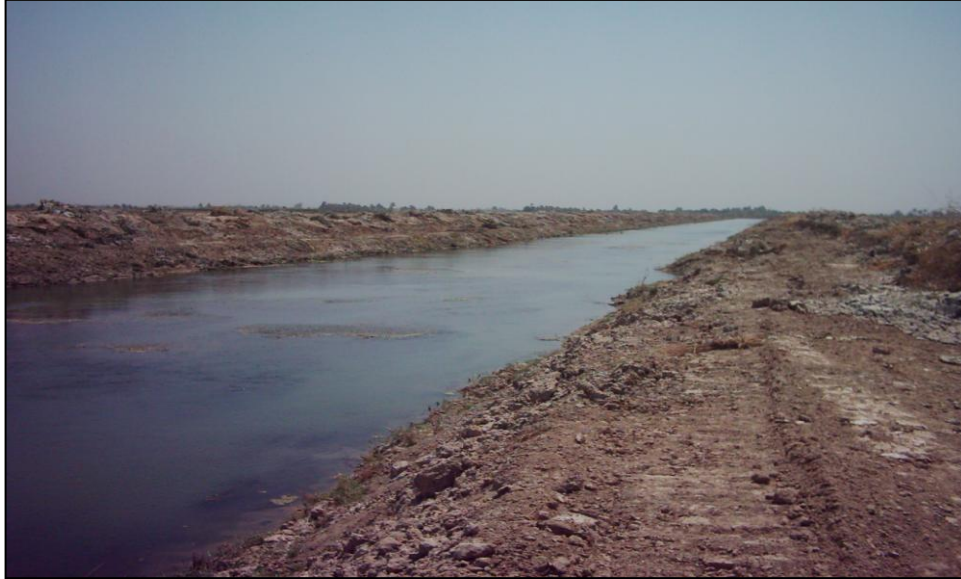
Canals after cleaning

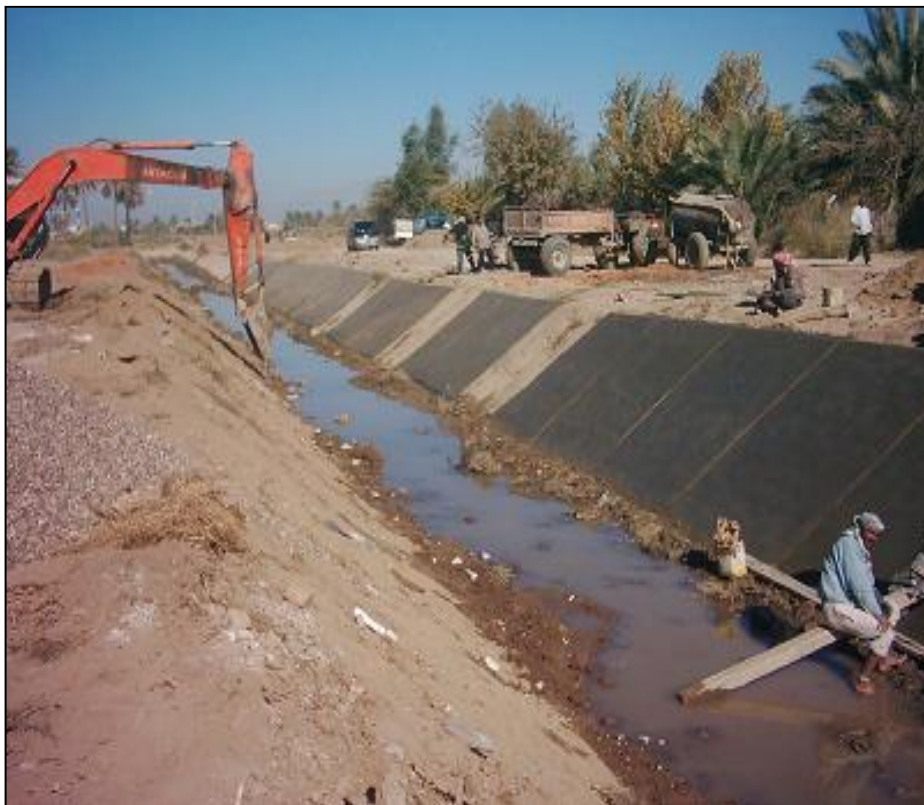
Canal Lining

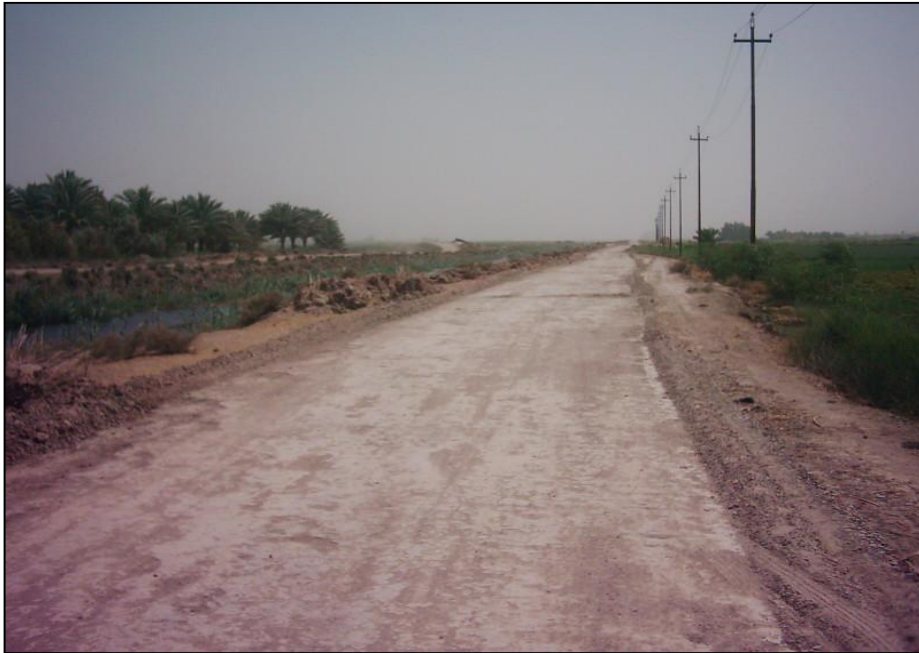
Annex 3 Road Construction

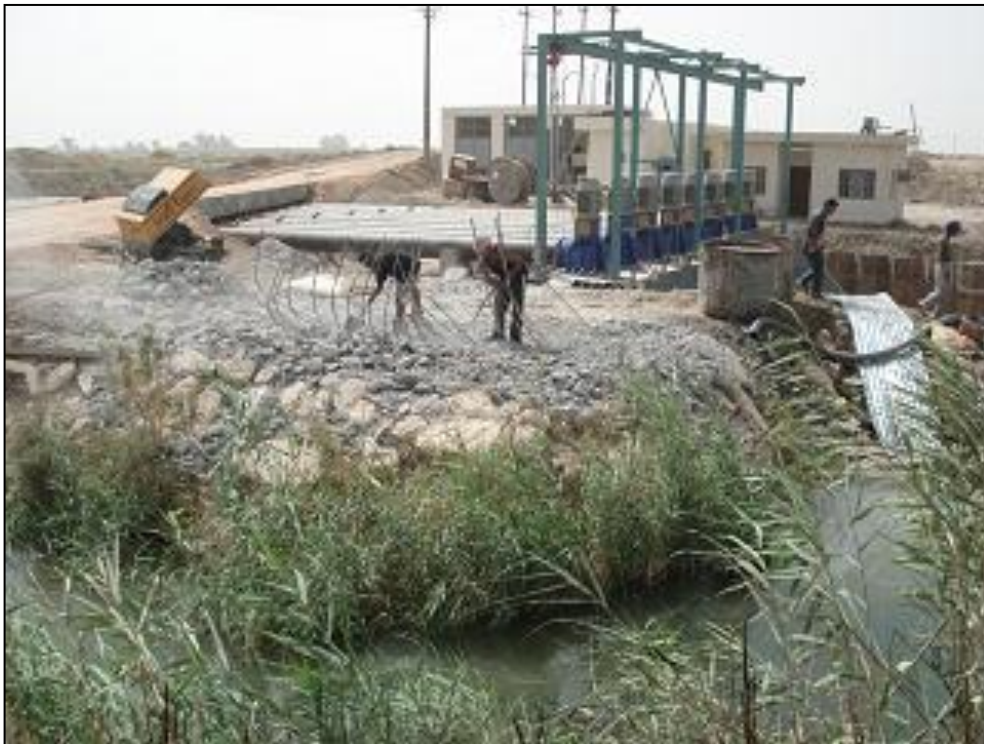
Drain 22 Pumping Station

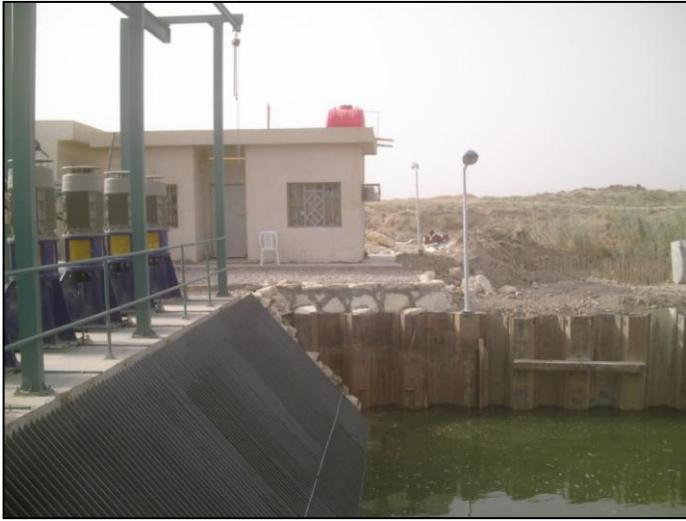
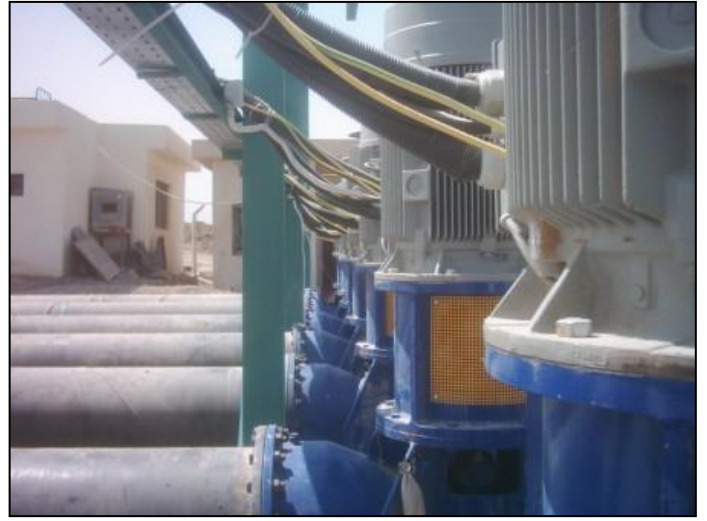
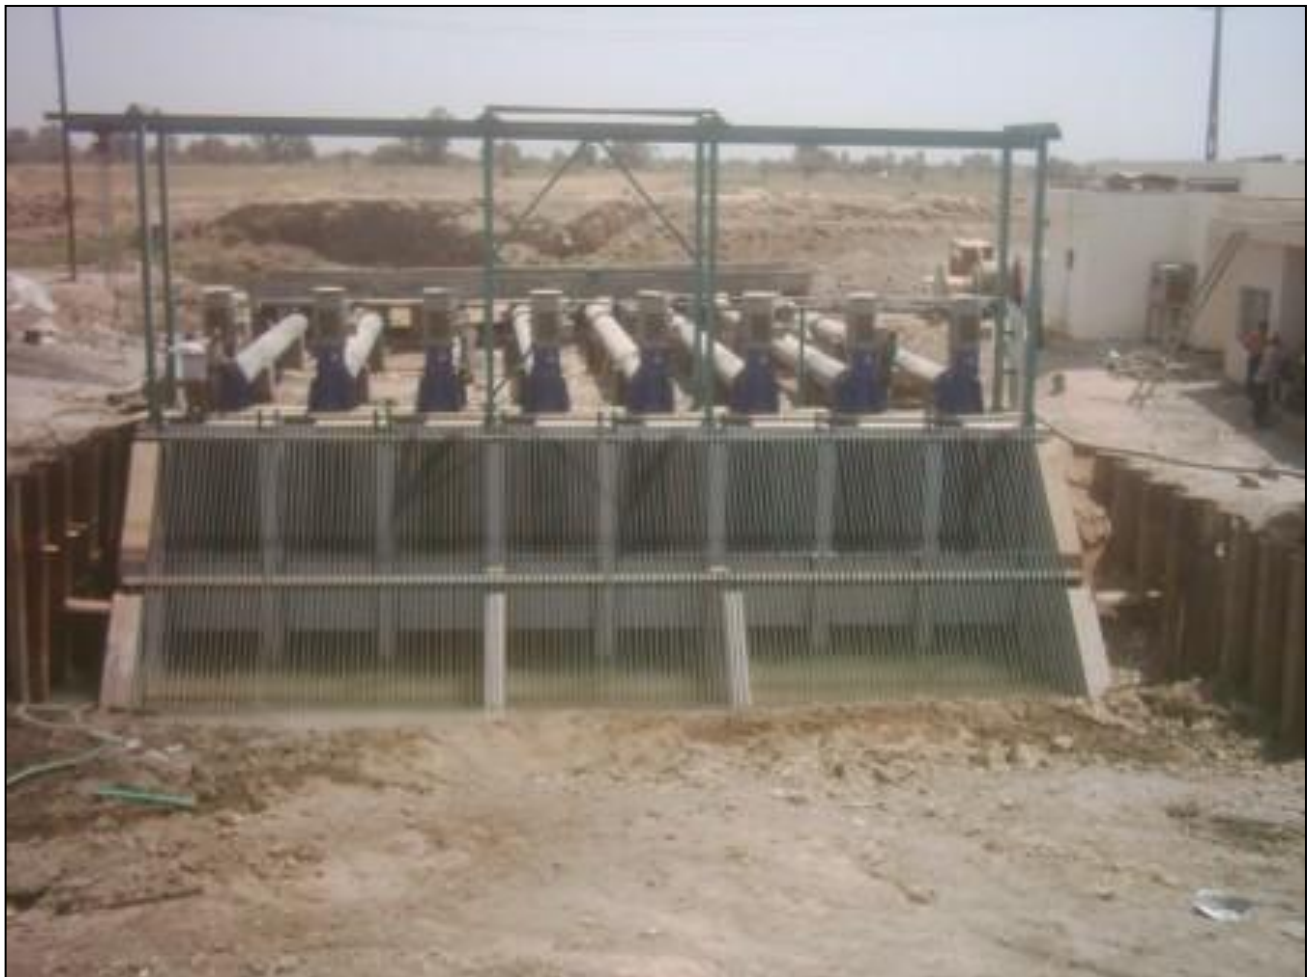
Drain 22 Pumping Station
